PETERSBURG EAST, W. VA.
NE/4 PETERSBURG 15 QUADRANGLE
N3852 5—W7900/7 5
1969

LANDSLIDES AND RELATED FEATURES

OF THE PETERSBURG EAST, W. VA. QUADRANGLE
by
Roger E. Thomas and Robert J. Hackman
1980
U.S. Geological Survey
OPEN FILE MAP 80-194 (H-3)

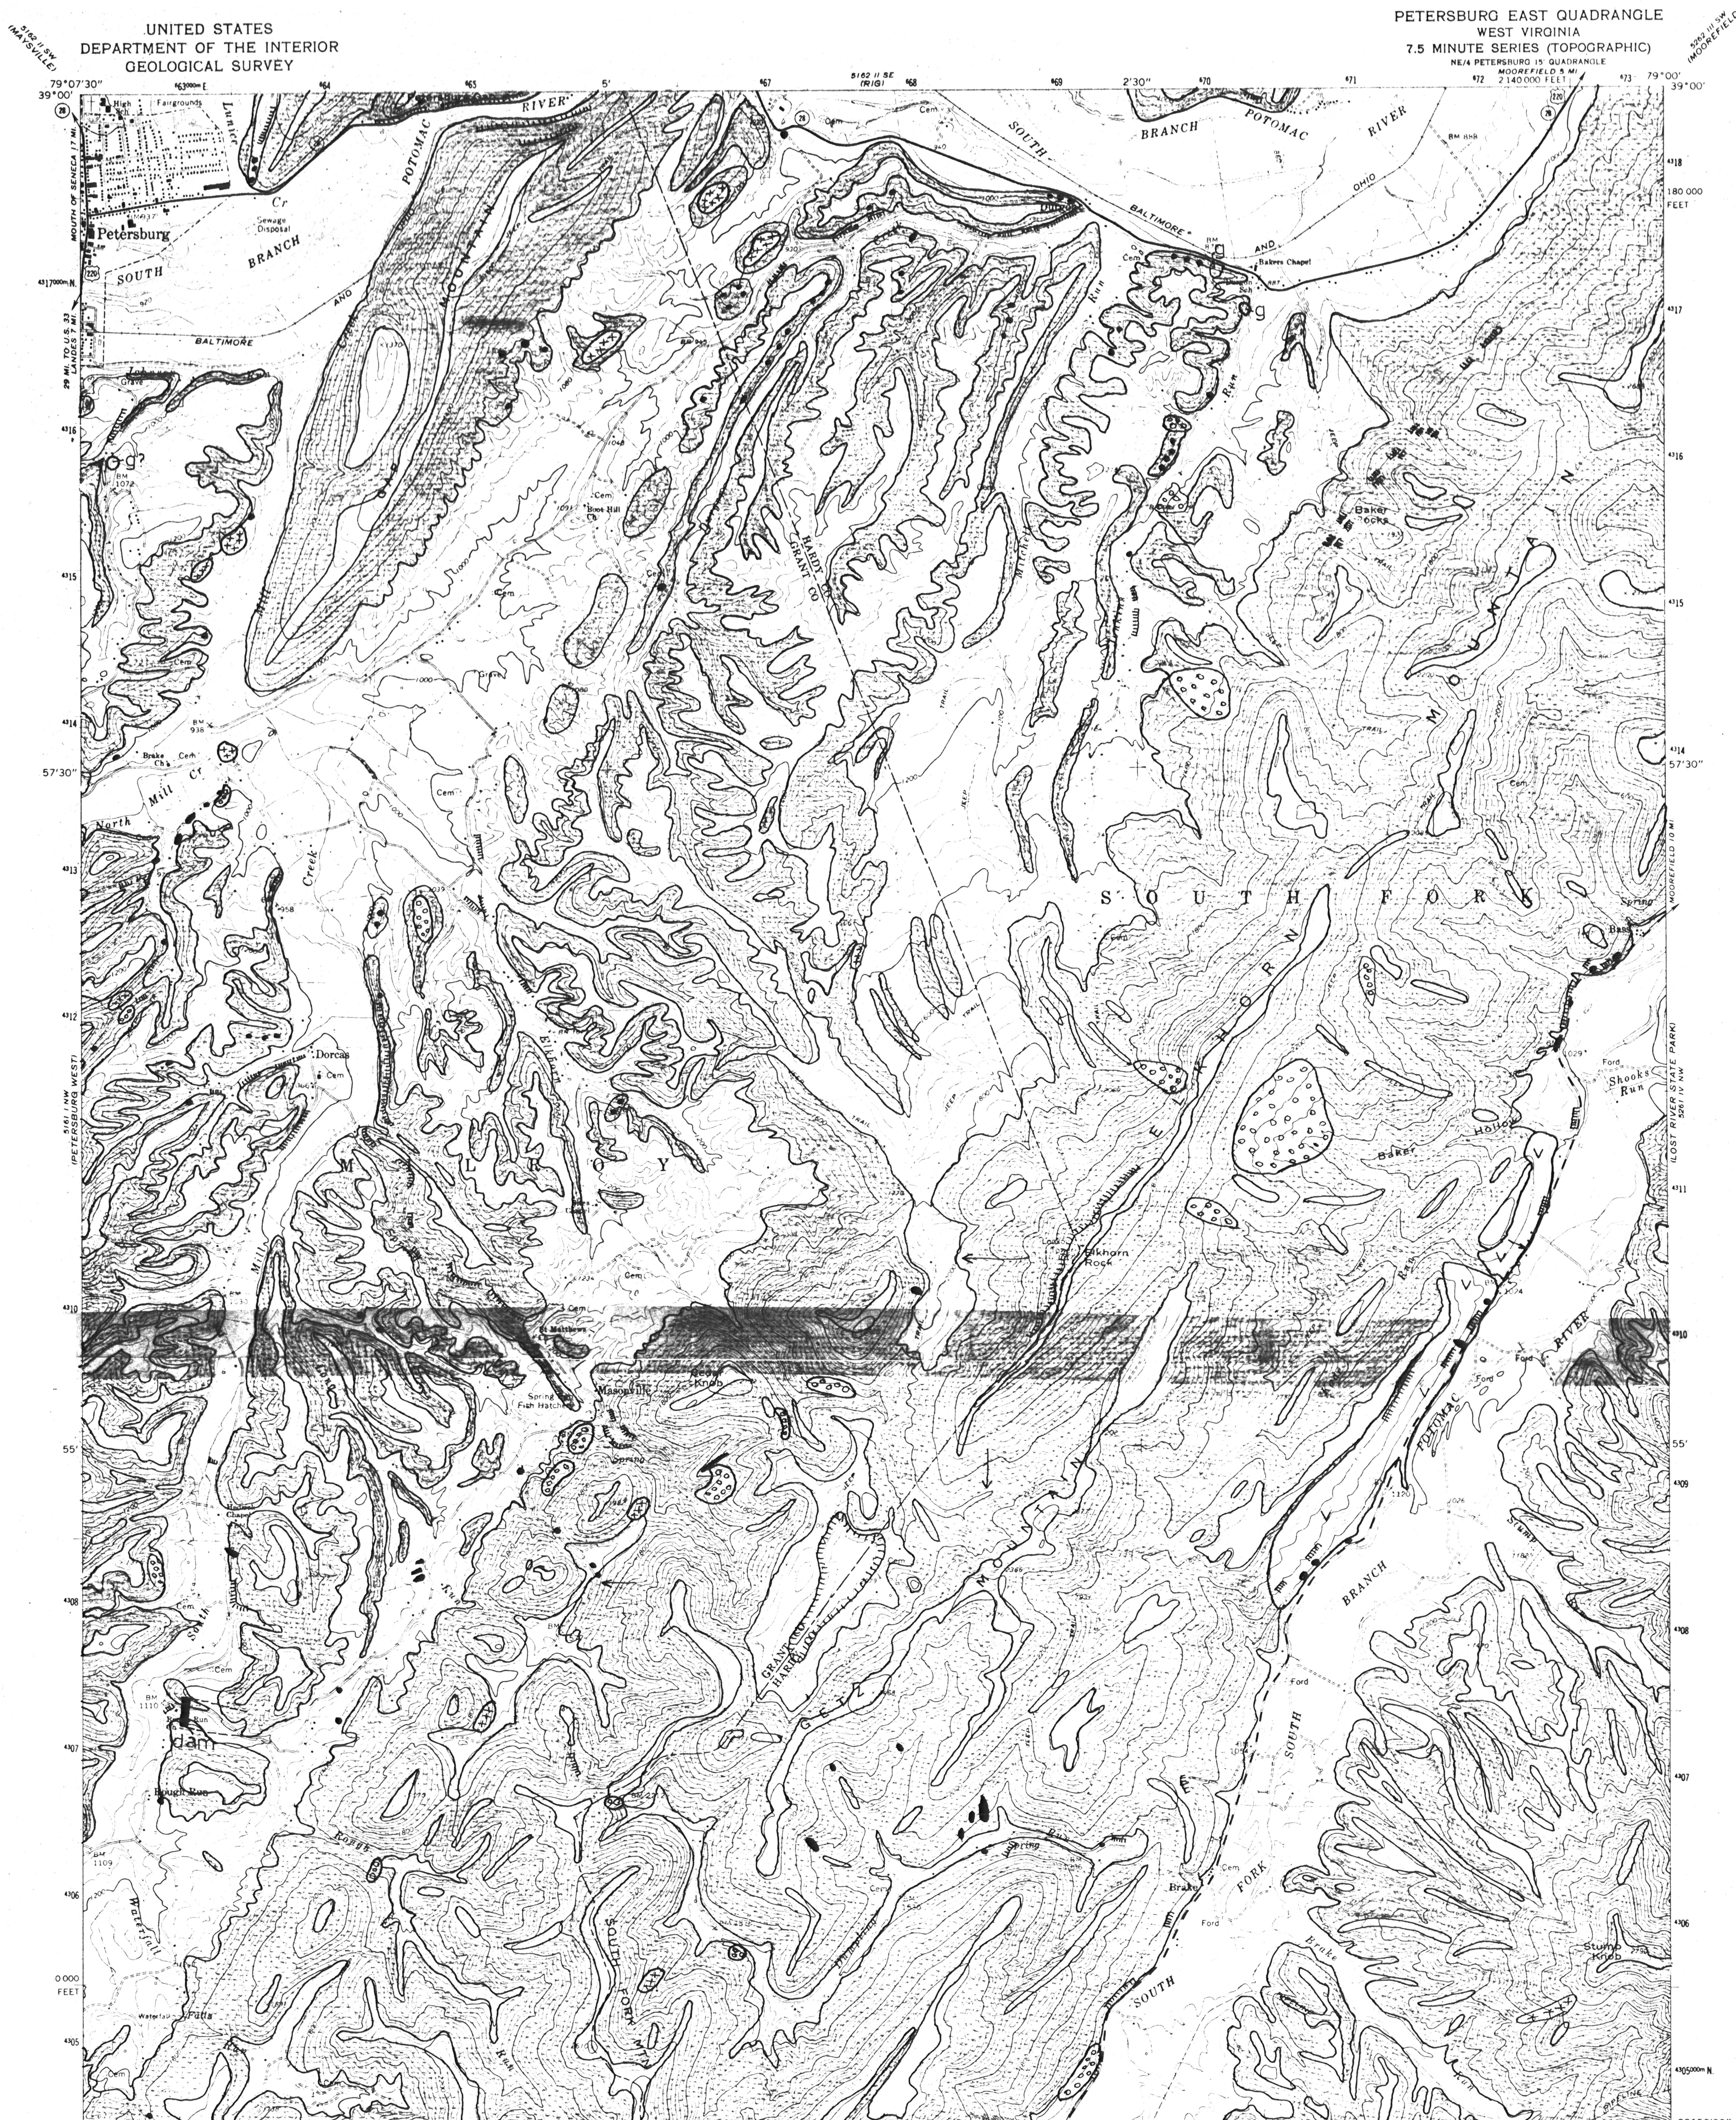
Landslides and related features interpreted from aerial photographs:
1:50,000 (black and white) 1959, 1960
1:79,000 (black and white) 1977

Photointerpretation and field check 1979
This map has not been edited or reviewed for conformity with Geological Survey standards and nomenclature.

- ACTIVE OR RECENTLY ACTIVE LANDSLIDE**
Complex landslide composed of earthflow, debris slide, earth and rock slump. Identified from historical records, and from scars, debris and other field evidence. Ground extremely unstable; sliding accelerated by excavation, loading and changes in drainage conditions. May include areas with several active slides too small to be shown separately. Questioned where doubtful.

- OLD LANDSLIDE**
Area of extensive hummocky ground caused by earthflow and earth and rock slump. Lacks clear evidence of active sliding. Relatively stable in natural, undisturbed state, generally not affected by small structures properly sited in areas away from the edge of the toe; can be reactivated by extensive, rapid excavation, loading, and changes in ground water and surface water conditions. Area of old landslide probably includes recent ones not identified from field evidence or otherwise documented. Upslope boundary of landslide generally defined by modified scarp, but downslope (toe) may be gradational and not well defined. Questioned where doubtful.

- COMBINATION LANDSLIDE**
Area of recent and old slides in which individual slides are not identified.
- COLLUVIAL SLOPE**
Valley wall along major streams with slope as steep as 40° (85%); stony, clayey silt soil up to 50 ft. (15 m) thick; commonly buttressed by a terrace or bench at the toe of the slope; very susceptible to sliding by cutting of toe area, removal of terrace or bench, and overloading; slide commonly activated without apparent cause.

- COLLUVIAL SLOPES WITH LANDSLIDES**
Landslides too small or obscure to map individually.
- AREAS SUSCEPTIBLE TO DEBRIS FLOWS AND DEBRIS AVALANCHES**
Primarily shallow, narrow ravines and chutes with accumulation of stony colluvium generally 10 ft. (3 m) or less in thickness; susceptible to rapid movement during intense rainfall. Most ravines and chutes designated show evidence of former debris flows and avalanches. Symbol & designates historical debris flow or debris avalanche.

- AREAS SUSCEPTIBLE TO ROCKFALL**
Steep, locally vertical, natural and man-made slopes and cliffs, 15 ft. (4.5 m) or more high; formed dominantly of sandstone, limestone, sandy shale, mudstone and claystone. Interbedded mudstone, claystone and shale weather rapidly leaving sandstone and limestone rock faces unsupported.

- SOIL AND ROCK SUSCEPTIBLE TO LANDSLIDING**
Soil and rock similar to that involved in landslides elsewhere in map area; primarily areas underlain by claystone, mudstone and shale associated with other rock types. Rock weathers rapidly on exposure forming clayey soil highly susceptible to sliding. Includes cohes (U-shaped, shallow valleys) containing thick layers of clayey soil that are very susceptible to sliding where excavation breaks continuity of slope and where overlaid by artificial fill.

AREAS LEAST PRONE TO LANDSLIDES
Map areas in which no patterns or symbols are shown; primarily valley floors, ridge tops and broad benches; modification by excavation and fill may lead to local landslides.
